### NASA Contractor Report 3815

# Residual Strength of Five Boron/Aluminum Laminates With Crack-Like Notches After Fatigue Loading

R. A. Simonds

CONTRACT NAS1-17100 JULY 1984

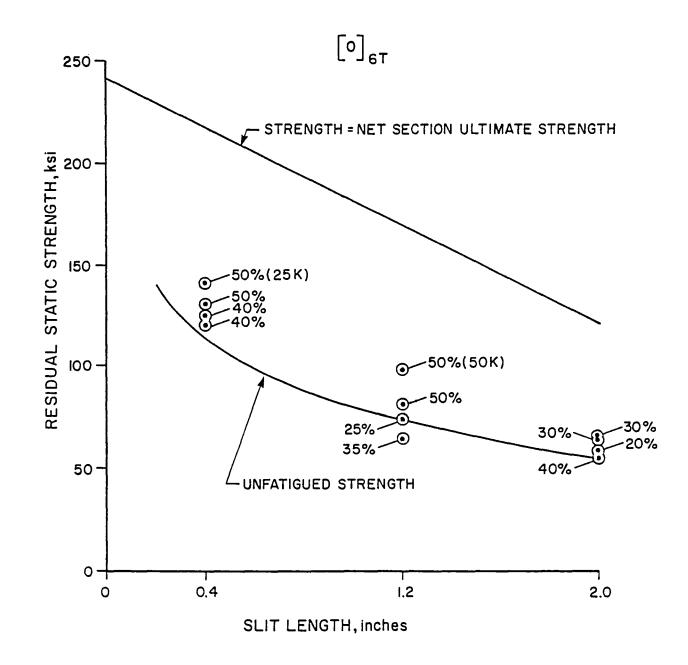
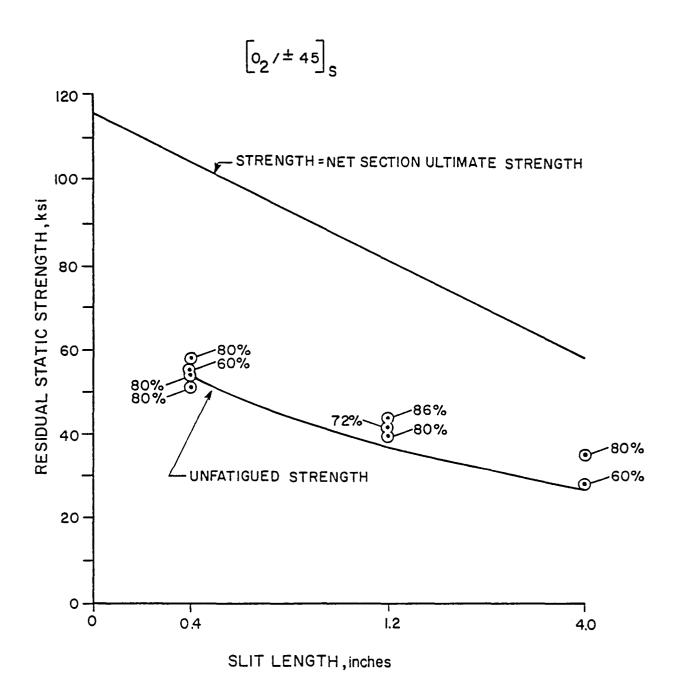
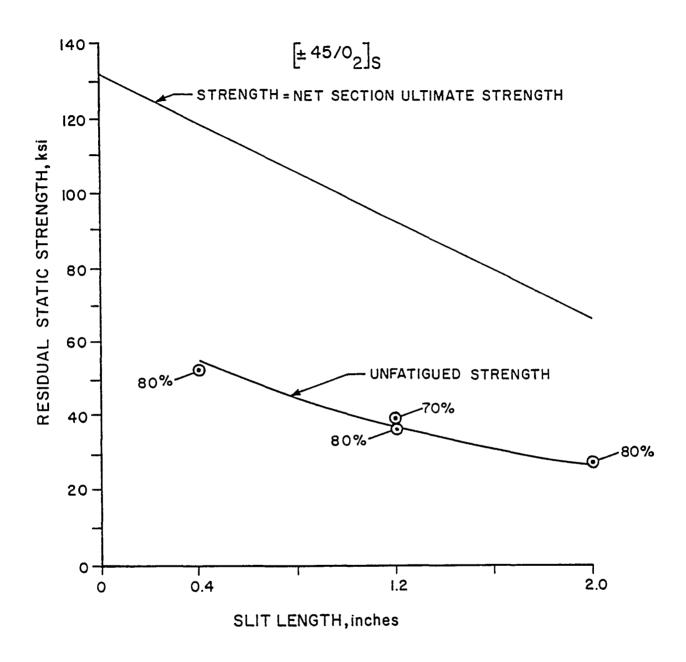
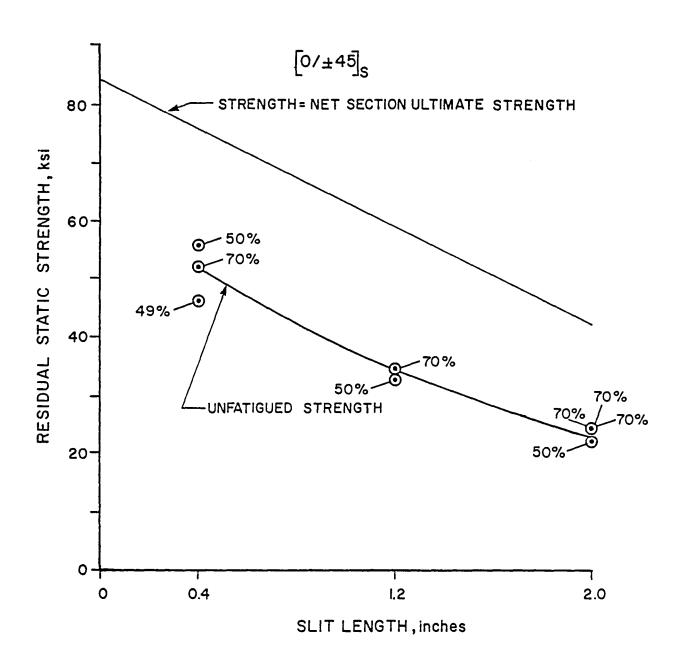
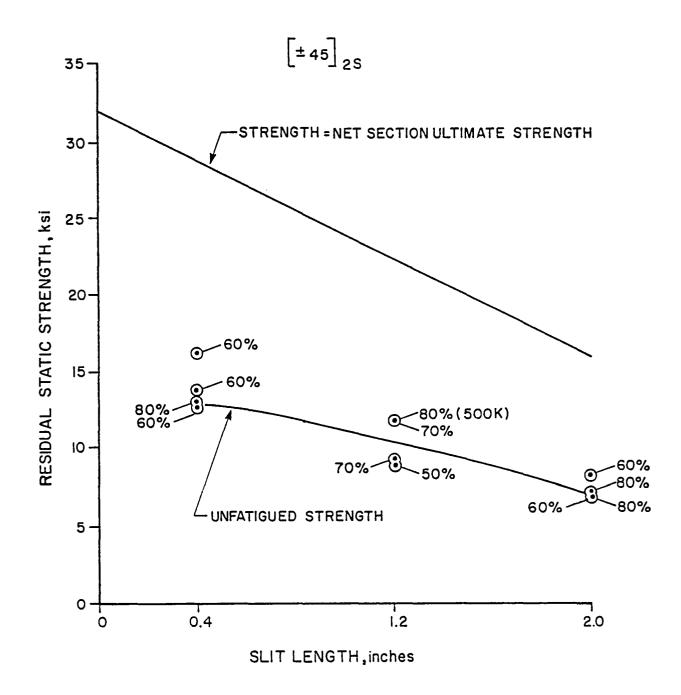
Fig. 2. Strengths of fatigued specimens compared with strengths of unfatigued specimens.

The results of all of the tests that were run are summarized in Table II. Figure 2 compares the fracture strength of the fatigued specimens with the average strength of the specimens from Ref. 1 that

In spite of the above damage, there is virtually no change in the strength of a fatigued boron/aluminum specimen containing a slit in the center compared to a similar specimen without fatigue.

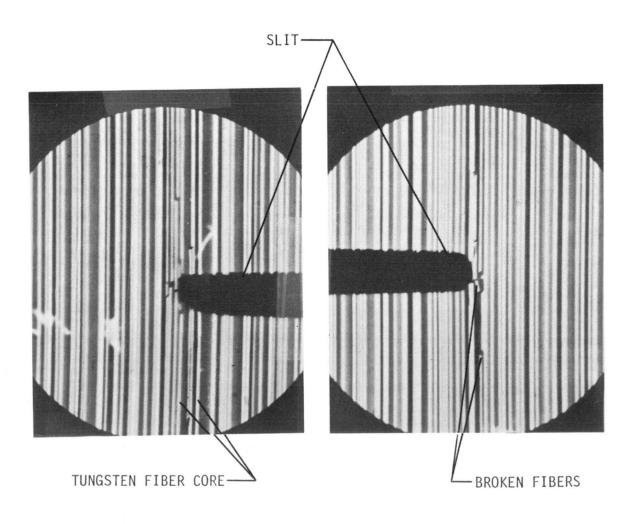
With the exception of one of the laminates, the preponderance of fiber damage occurred in the  $\pm 45^{\circ}$  plies rather than in the 0° plies. Figure 3 shows radiographs taken of the slit ends of specimen 04022, which was a  $[0]_{6T}$  laminate, after the specimen was fatigued for 100,000 cycles at 35% of the static fracture strength. The few fibers that are broken, as indicated by the gaps in the white line images of the tungsten fiber cores, all occur in the immediate vicinity of the ends of the slit. Specimen 04022 experienced a very slight increase in fracture strength over the average unfatigued strength.

Fig. 3. Radiograph of the ends of the slit of specimen 04022 after fatiguing.

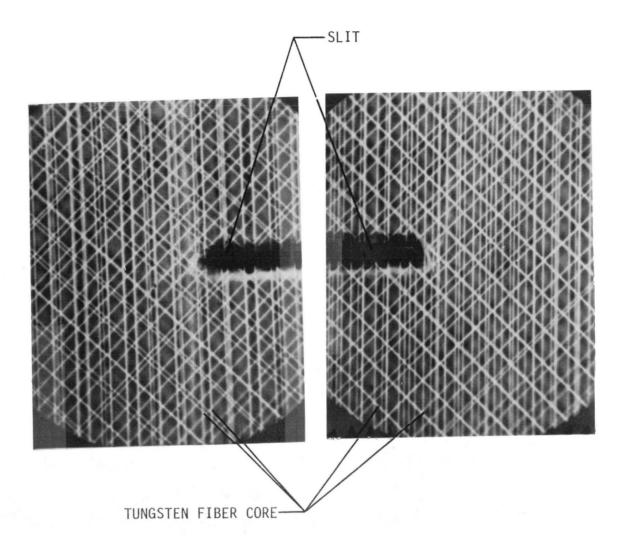
Figure 4 is a radiograph of the ends or the slit of specimen 43032 which is a  $[0_2/\pm45]_{\rm S}$  laminate. Negligible damage to the fibers can be seen in the radiographs. Figure 5 shows the first and second plies, both 0° of the same specimen after matrix removal, as viewed in the scanning electron microscope. Zero degree fibers, except those actually cut by the slit, are intact. However, the 45° fibers, as shown in Fig. 6, show extensive damage that was not apparent in the

Fig. 4. Radiograph of the ends of the slit of specimen 43032 after fatiguing.

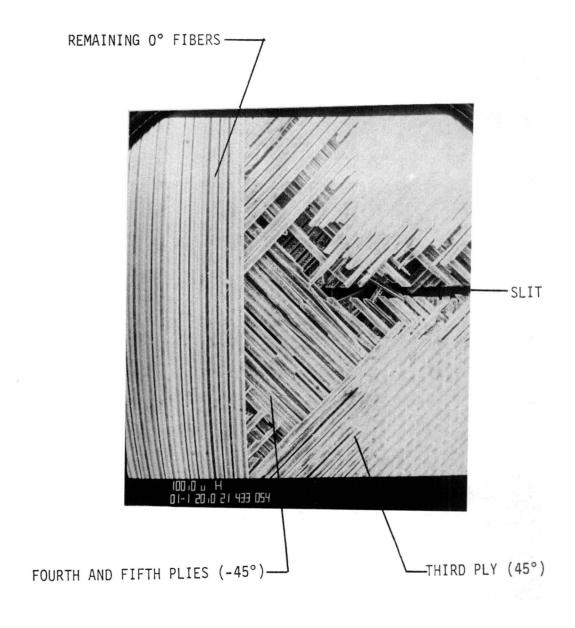
radiographs. The 45° fibers appear to have split and washed away during matrix removal.

Unpublished work by C. C. Poe, Jr. of NASA Langley Research Center indicates that the 45° fibers are subjected to large tensile stresses transverse to the fibers. Thus, the 45° fibers could have broken because their transverse fatigue strength is low. The asymmetrical pattern of damage in Figs. 6, 7, 11, and 12 is consistent with such a failure mode. Similar fiber damage was noted in Refs. 4 and 5.

Fig. 6. Scanning electron micrograph of  $45^{\circ}$  fibers of specimen 43032.

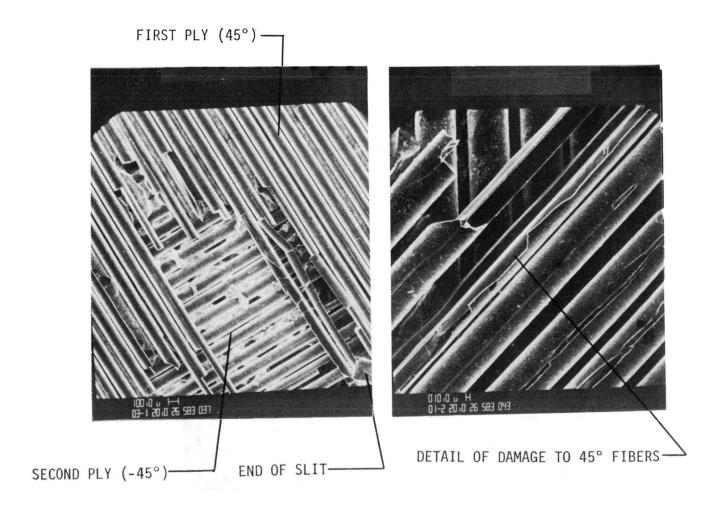
Figures 7 and 8 show similar damage to  $45^{\circ}$  fibers and  $0^{\circ}$  fibers respectively in specimen 58032. This specimen is a  $[\pm 45/0_2]_{\rm S}$  laminate giving it equal proportions or  $45^{\circ}$  and  $0^{\circ}$  fibers as specimen 43032, but a different stacking sequence. Figure 7 indicates a detail of the  $45^{\circ}$  fibers showing the type of damage they suffer in the fatigue loading. Figure 8 shows the relatively undamaged  $0^{\circ}$  fibers toward the center of the specimen.

Fig. 7. Scanning electron micrograph of 45° fibers of specimen 58032 with matrix removed.

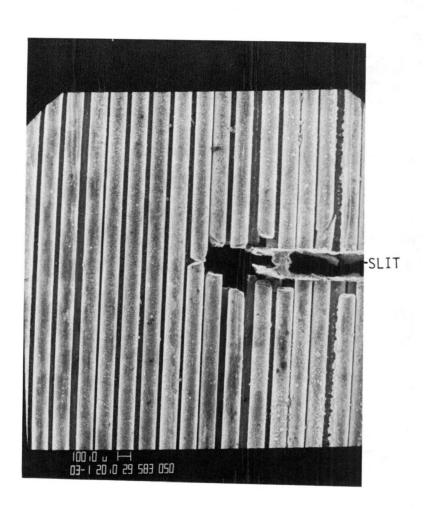
Fig. 8. 0° fibers of specimen 58032 after fatiguing with matrix and overlying 45° fibers removed.

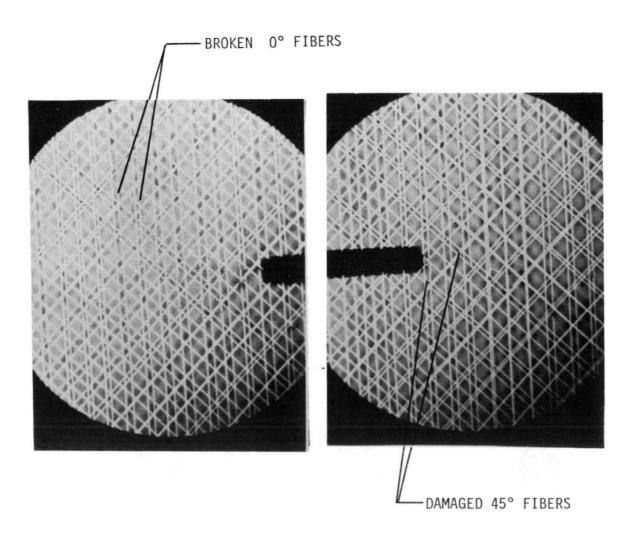
Laminate  $[0/\pm45]_{\rm S}$  was the only one of the five laminates to show significant damage to the 0° fibers as a result of the fatigue loading. Some of the radiographs of specimens of this laminate show broken 0° fibers as far as eight fibers away from the ends of the slit. Figure 9 is a radiograph of specimen 31022 showing broken 0° fibers as well as broken 45° fibers. Figure 10 shows the results of fatiguing specimen 31012 for 100,000 cycles at 70% of the estimated failure load, sectioning the specimen, then leaching the matrix away with sodium hydroxide to expose broken 0° fibers. Further leaching reveals extensively damaged 45° fibers (Fig. 11) as seen in the other laminates containing 45° fibers.

Fig. 9. Radiographs of ends of slit of specimen 31022 after fatiguing.

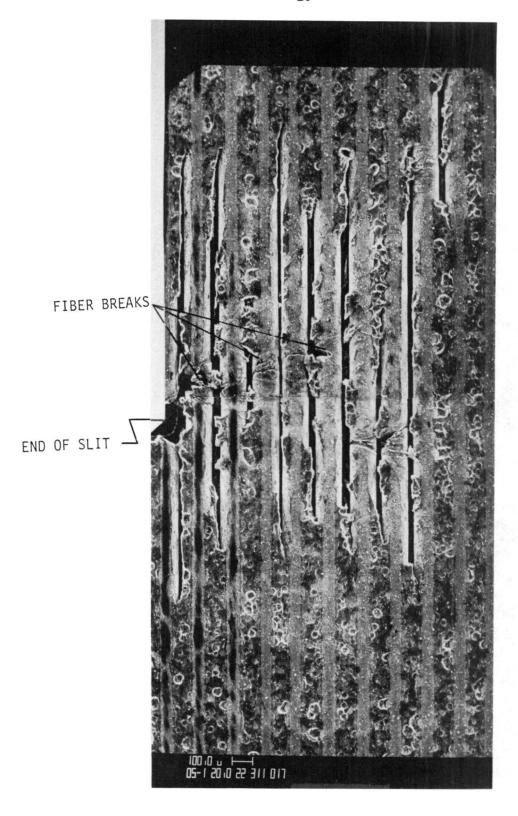
Fig. 10. 0° fibers at end of slit of specimen 31012 fater fatiguing and with matrix partially removed.

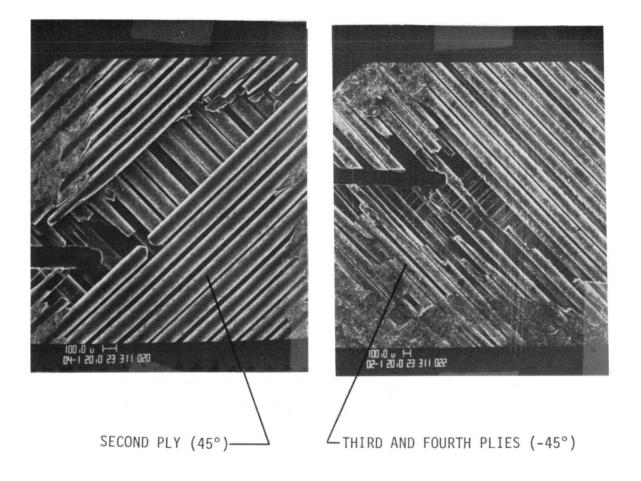
Fig. 11. Scanning electron micrograph of  $45^{\circ}$  fibers at end of slit of specimen 31012 after fatiguing with matrix and overlying fibers removed.

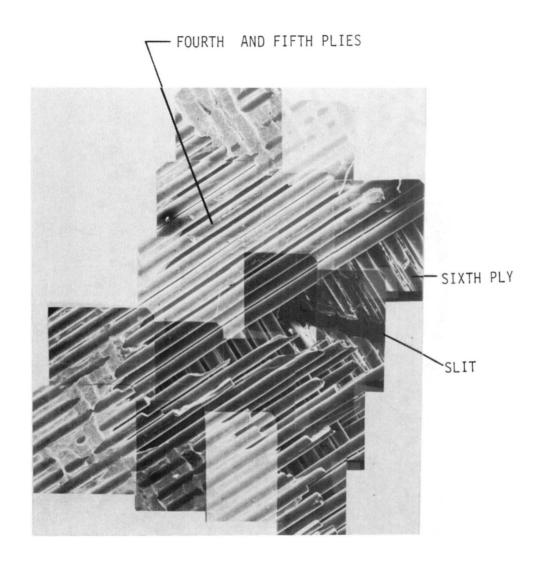
Damage to fibers in the  $[\pm 45]_{2s}$  laminates appears to be similar to the damage to  $45^\circ$  fibers in the other laminates even though there are no accompanying  $0^\circ$  fibers. Figure 12 shows the results of fatiguing specimen 13013 for 100,000 cycles to 70% of its average unfatigued static strength. A portion of the specimen taken from the area of one end of the slit was leached in sodium hydroxide to remove the top three plies to reveal the middle two plies, both parallel to one another, and

portions of the underlying 6th ply. The fibers are extensively damaged and many of the broken pieces have simply fallen away from the section once the matrix was dissolved away.

Fig. 12. Scanning electron micrograph of specimen 13013 showing 4th and 5th plies  $(45^\circ)$  and 6th ply  $(-45^\circ)$  at end of slit after fatiguing and with matrix removed.

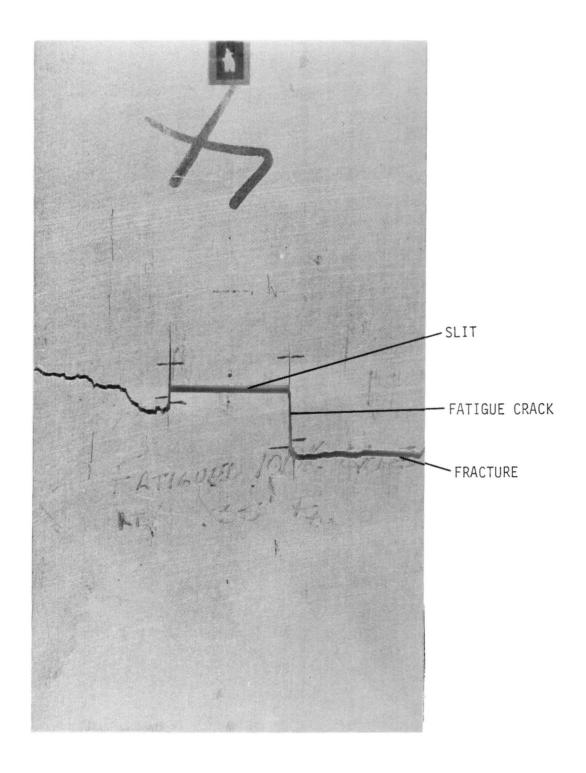
Matrix damage in the boron/aluminum laminates subjected to fatique loading appeared to take two forms: cracks in the 0° plies which started at the ends of the slits, grew parallel to the 0° fibers, through the specimen thickness, and towards the grips with increasing numbers of cycles; cracks in the 45° plies originating at split 45° fibers. In addition, some cracks were observed between 0° plies and adjacent 45° plies. In the [0]<sub>6T</sub> laminates, cracks developed very quickly at the ends of the slits and grew very quickly along the 0° fibers towards the grips. The matrix cracks in the  $[0]_{6T}$  specimens grew so quickly that the  $[0]_{6T}$  specimens were fatigued at lower percentages of their static fracture strengths. Figure 13 is a photograph of specimen 04022 showing that the fatigue cracks grew from the ends of the slit and then that the specimen fractured at the ends of the fatigue cracks rather than at the ends of the slit. Pencil marks were made on the surface of the specimen at the visible ends of the fatigue cracks after the fatigue portion of the testing. During the subsequent

fracture testing, the specimen fractured from the ends of the fatigue cracks rather than from the ends of the original slit. This behavior is in agreement with the predictions of shear lag analysis (Ref. 3). At fracture, there was some additional cracking in the  $0^{\circ}$  directions as there was in the fracture testing of unfatigued  $[0]_{6T}$  specimens with slits (Ref. 1).

Fig. 13. Photograph of fatigued and fractured specimen 04022.

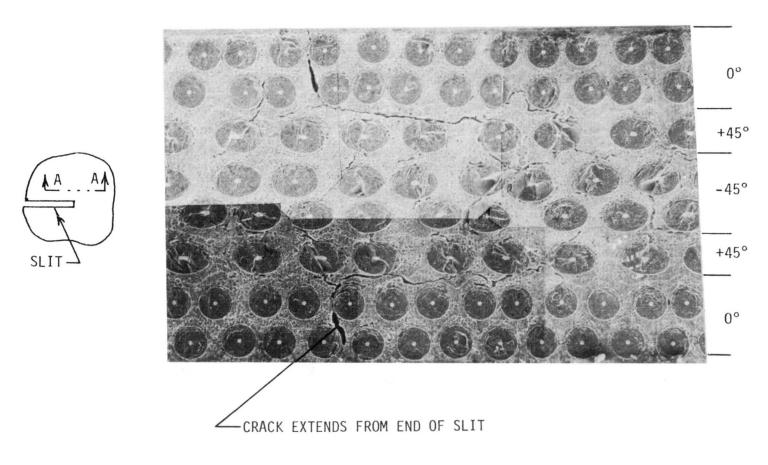
#### SECTION A-A

Figure 14 is a cross-section of specimen 43032,  $[0_2/\pm45]_S$ , slightly above the slit. The section has been etched with sodium-hydroxide to enhance the matrix cracks. It shows cracks at the end of the slit in the 0° plies, between the 0° and +45° plies, and in the 45° plies.

Fig. 14. Scanning electron micrograph of cross section of specimen 43032 near end of slit after fatiguing. Specimen was etched with sodium hydroxide to enhance cracks in matrix.

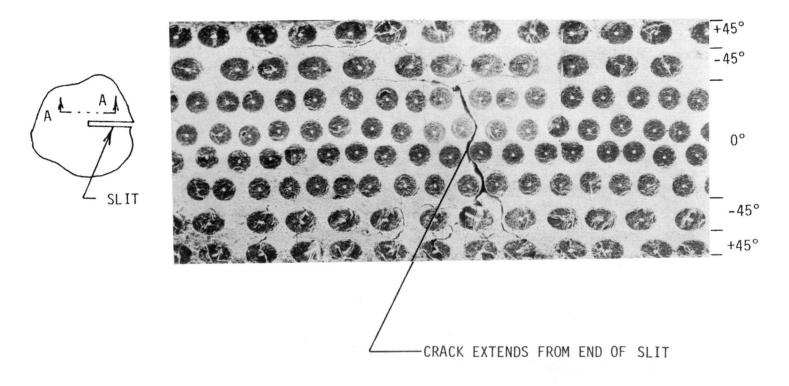
#### SECTION A-A

Specimen 58032,  $[\pm 45/0_2]$ , Fig. 15, shows virtually identical matrix cracking even though the stacking sequence is different. Figure 15 also shows that surface cracks occur coincident with fiber splits in the first 45° ply.

Fig. 15. Scanning electron micrograph of cross section of specimen 58032 near end of slit after fatiguing. Specimen was etched with sodium hydroxide to enhance cracks in matrix.

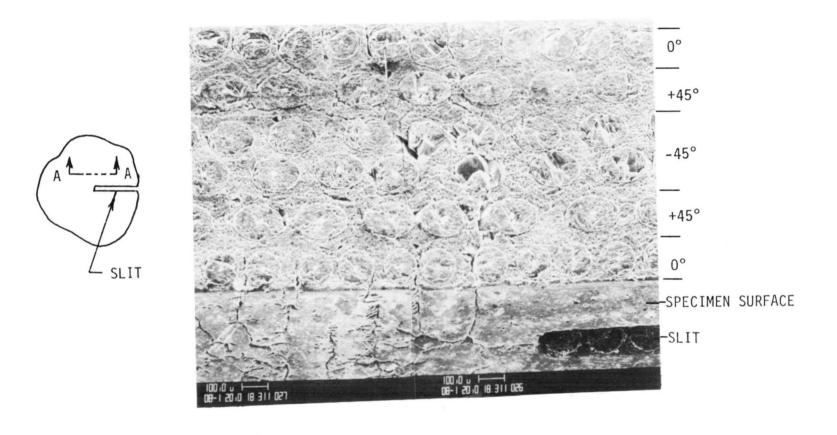
## SECTION A-A (TILTED TO SHOW SPECIMEN SURFACE)

Fatiguing of  $[0/\pm45]_S$  laminates with slits does not appear to create a single dominating matrix crack in the 0° plies as it does in the other laminates containing 0° plies. Instead, several cracks appear between adjacent 0° fibers as can be seen in Fig. 16. Note that the matrix cracks in the 0° plies are between the fibers as opposed to connected with split fibers as in the 45° plies.

Fig. 16. Scanning electron micrograph of cross section of specimen 31012 in vicintiy of end of slit after fatiguing. Specimen was etched in sodium hydroxide to enhance matrix cracks.
